Technical Preservation Services
Preservation Assistance Division
National Park Service
U.S. Department of the Interior
Washington, D.C.

Interpreting the Secretary of the Interior's Standards for Rehabilitation

Volume III

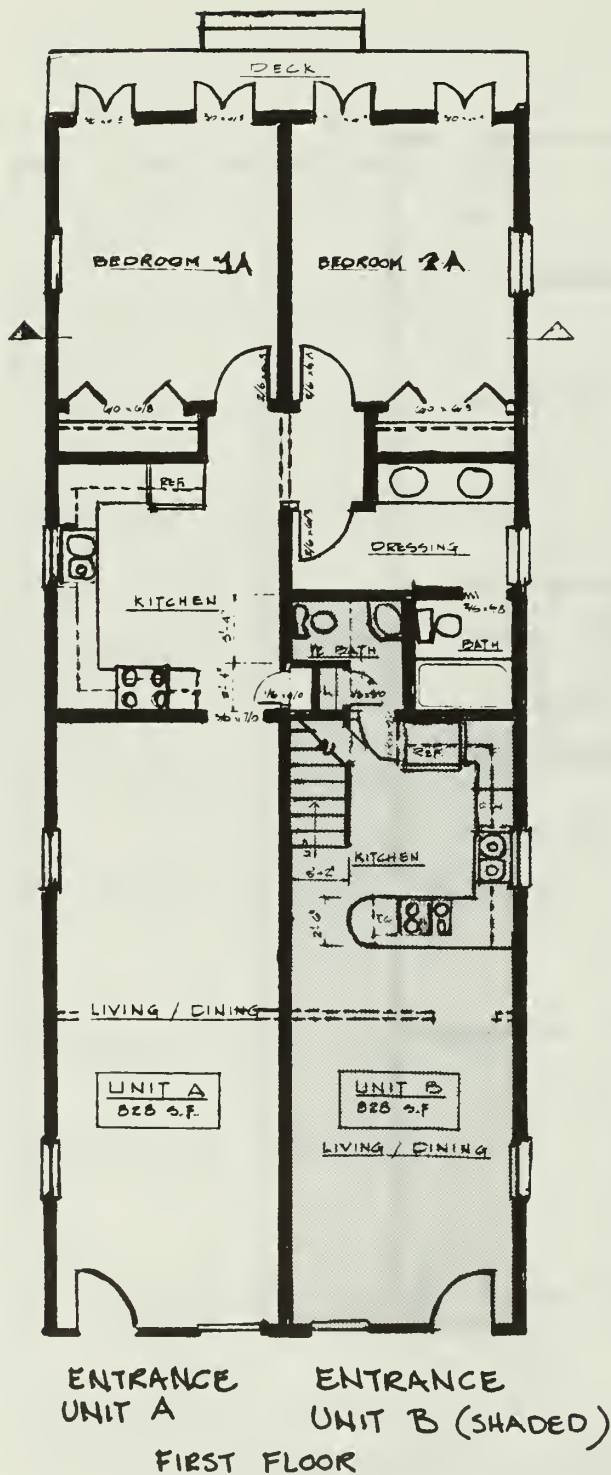
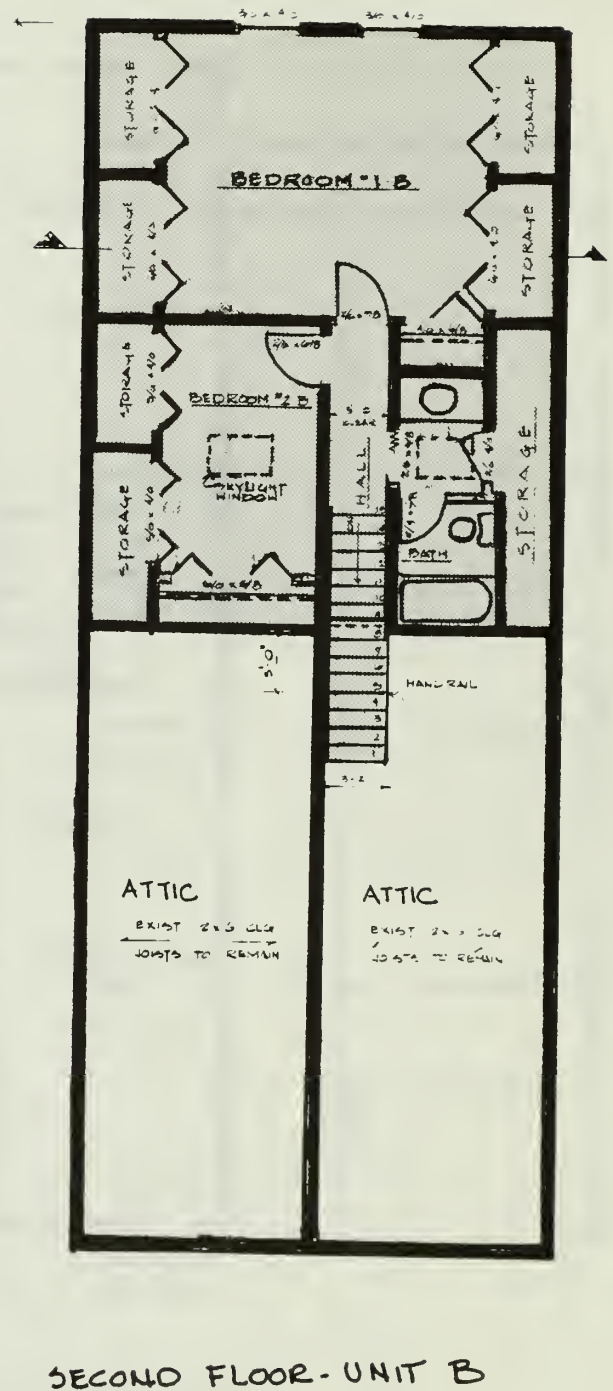
6a and 6b. After rehabilitation floor plan of 1890 building. The unit on the left now extends across the full width of the building in the rear half. To regain the floor space thus lost in the right unit, a stair was added, further altering the plan of this simple structure.

order to enlarge the apartments, the plan was further altered by incorporating almost the entire rear half of the right unit into the left unit. The floor space lost to the right unit was regained through the addition of a stair to the attic, into which two bedrooms were added. In this project the damage done to the historic character of this modest building is extreme. The units no longer convey a sense of the original "shotgun" plan. Construction of the stair in the right unit has further drastically altered the structure by introducing a vertical element missing from the historic plan. Finally, the division between the halves of the building was effectively destroyed in the rear half of the building. Accordingly, the project fails to meet the Secretary of the Interior's "Standards for Rehabilitation."

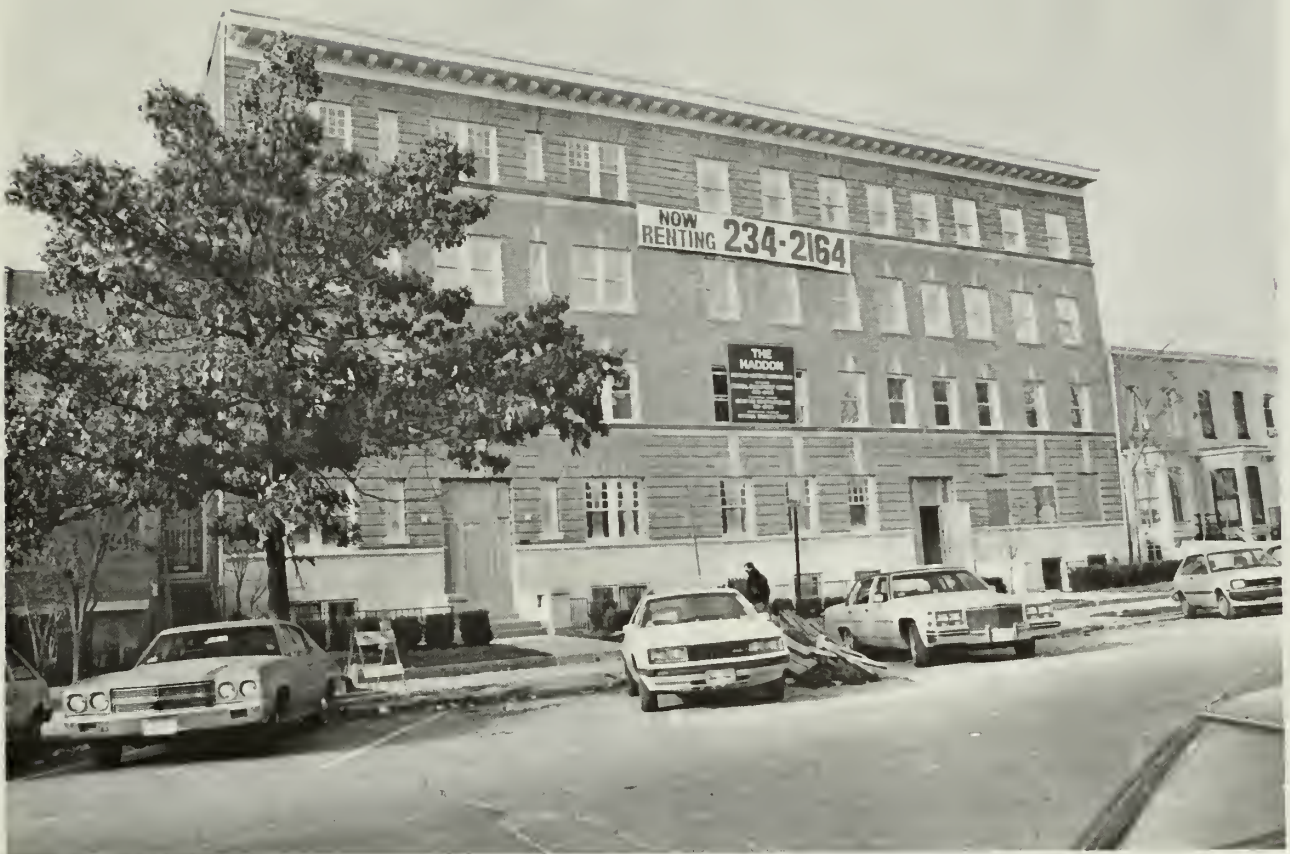
1. This early twentieth century apartment building was actually constructed as two buildings of harmonious but slightly different design.

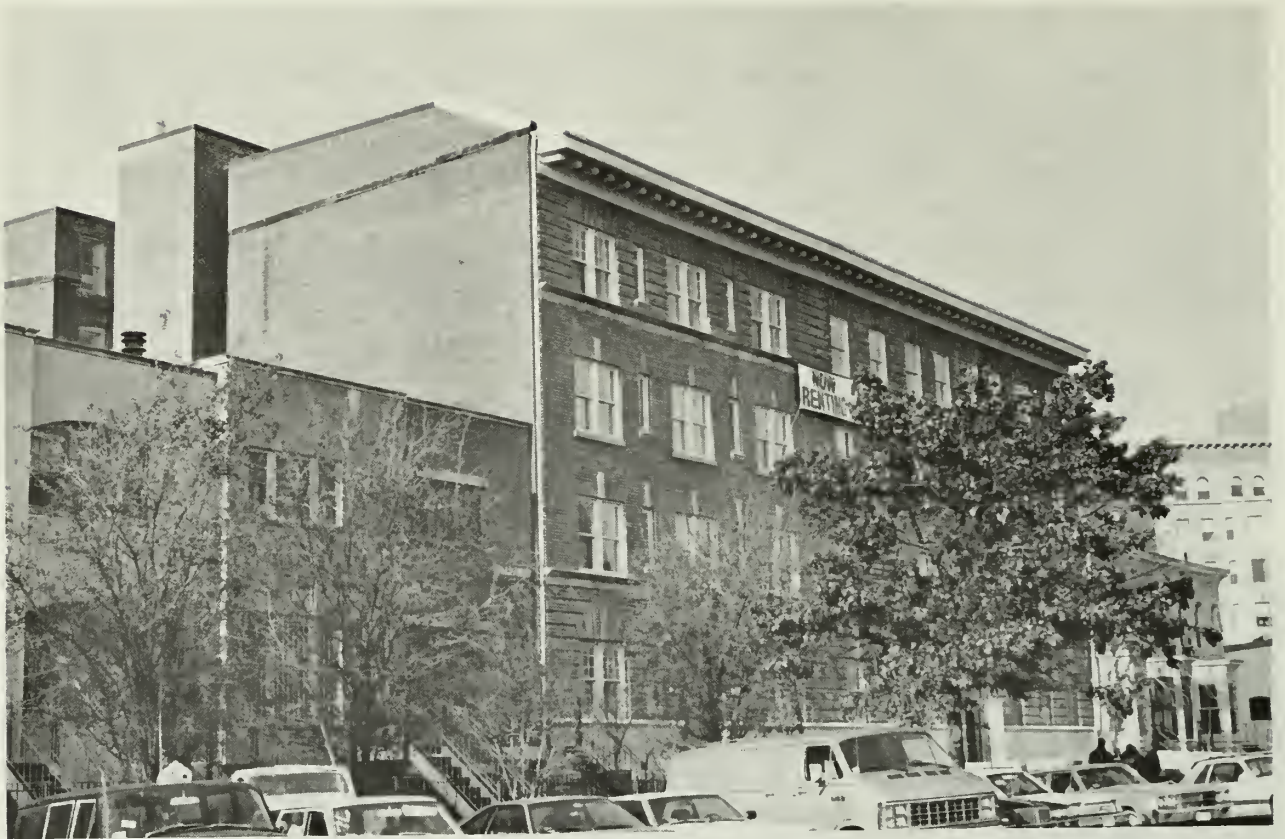
2. New rooftop addition and stairtower visible on the south elevation.

However, using a setback design concept linked to the cornice by a sharply slanted pent roof, another floor was added that is only minimally visible on the non-significant side elevations, and cannot be seen from the other side of the street directly across from the building (see illus. 1). The new rooftop addition and staintower (see illus. 2-3) is visible only on the non-significant and non-character-defining north and south elevations of the building. The fact that there are skylights inserted into the new pent roof is also unknown to passersby. From the public wayfare the new addition is visible only on the non-significant side elevations in the new brickwork rising above the original roofline, and the staintower. This rooftop addition thus preserves the historic character of this building, and is in conformance with the Standards.

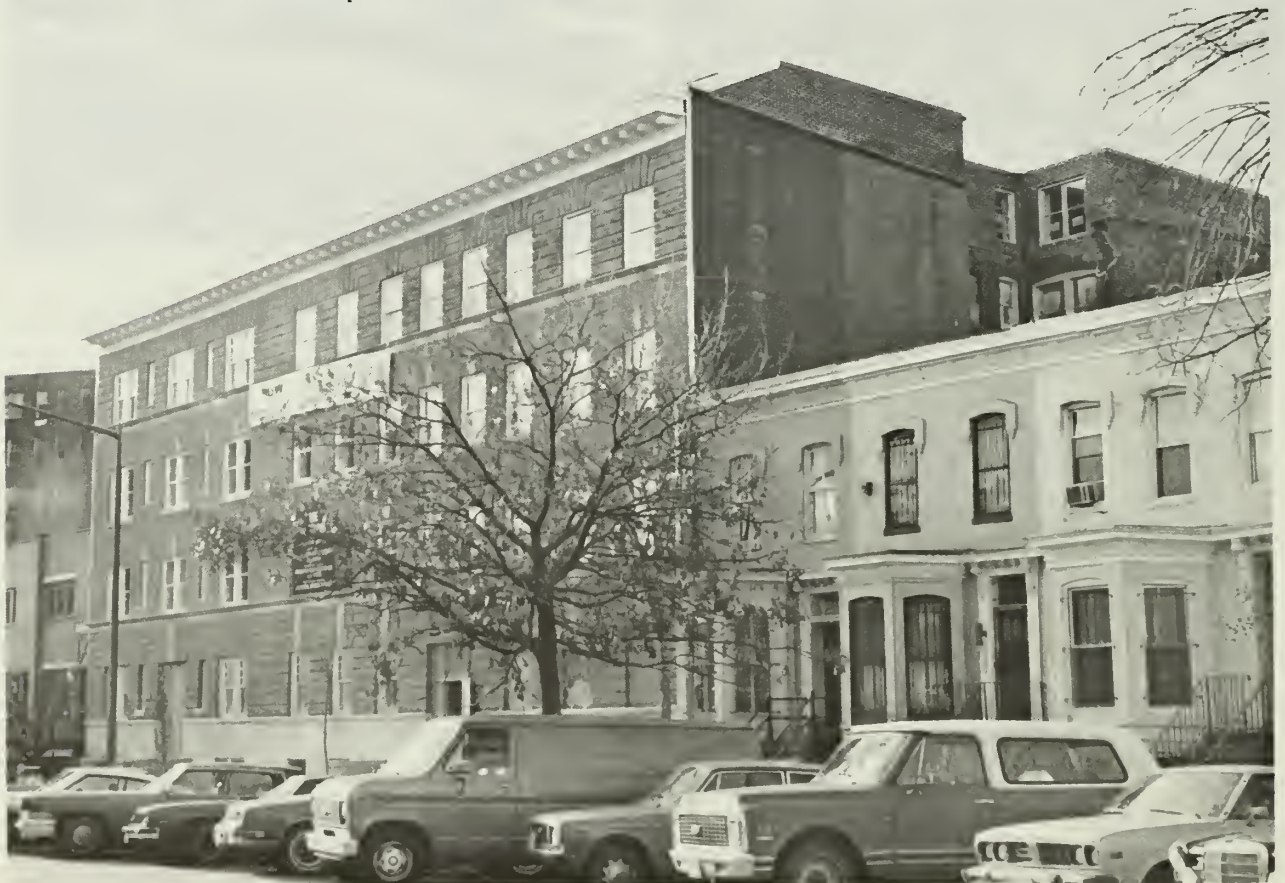
3. New rooftop addition visible on the north elevation.

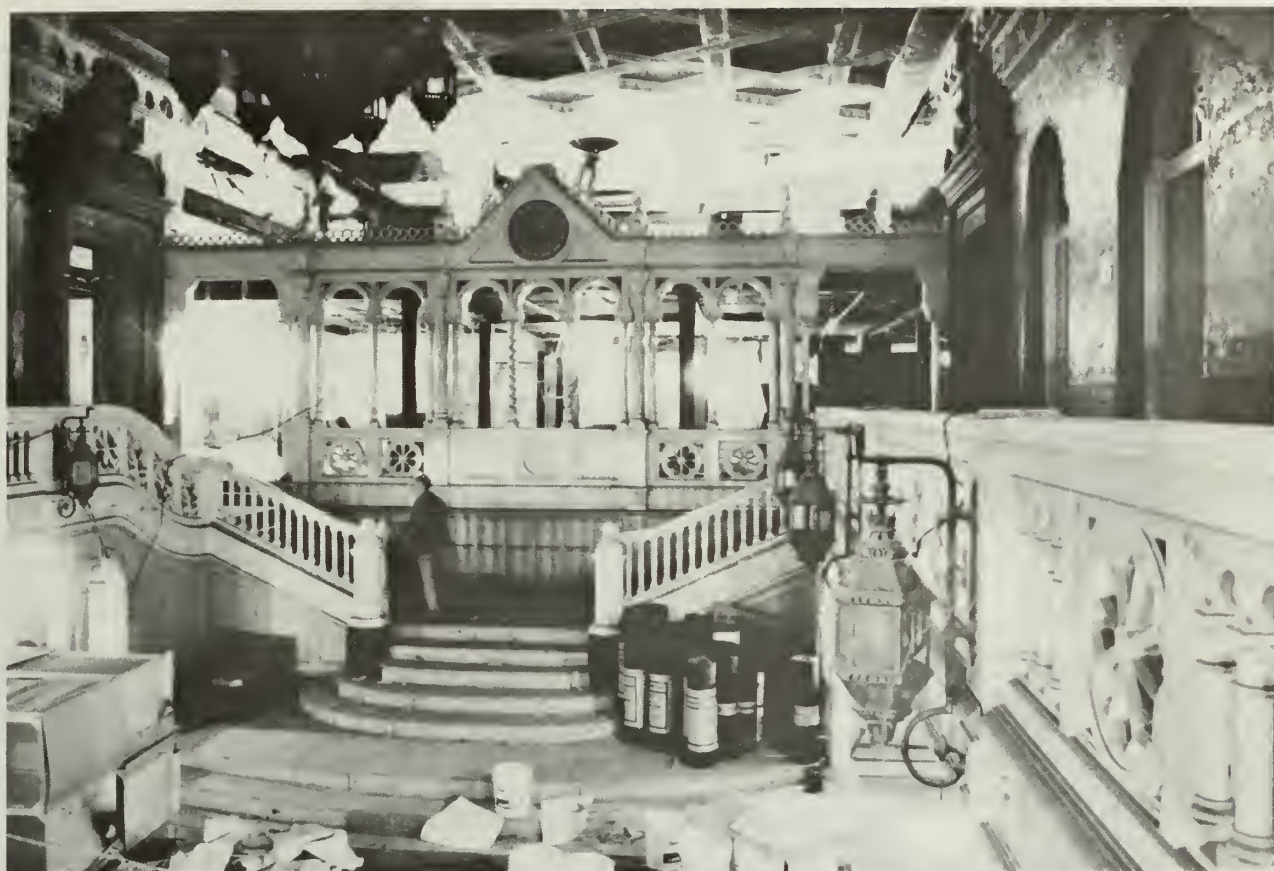
1. Lobby before rehabilitation. Ornamental screen at top of stairs leads to two other formal open spaces, the palm room and the dining room.

The insertion of a solid partition behind the open screen effectively cut off the lobby from the palm room. The damage wrought by the rehabilitation to the individual spaces thus exceeded the demolition of individual features or their incorporation into smaller rooms. The rehabilitation destroyed the formal organization of the spaces themselves. The progression from the grand, three-story lobby, up the elaborate split stair into the palm room and adjoining dining room was lost, and the historic character of the building irreparably harmed.

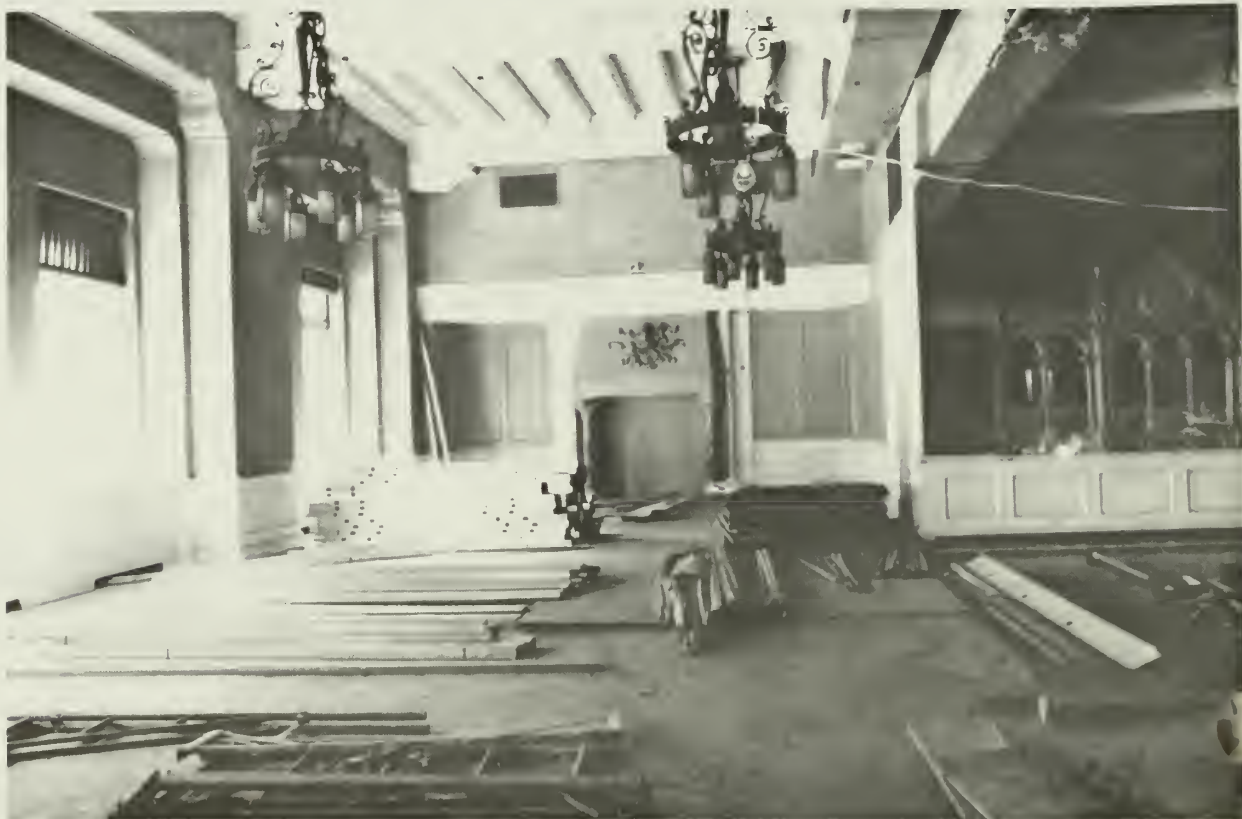
4. Dining room, before rehabilitation, and adjoining palm room (right).

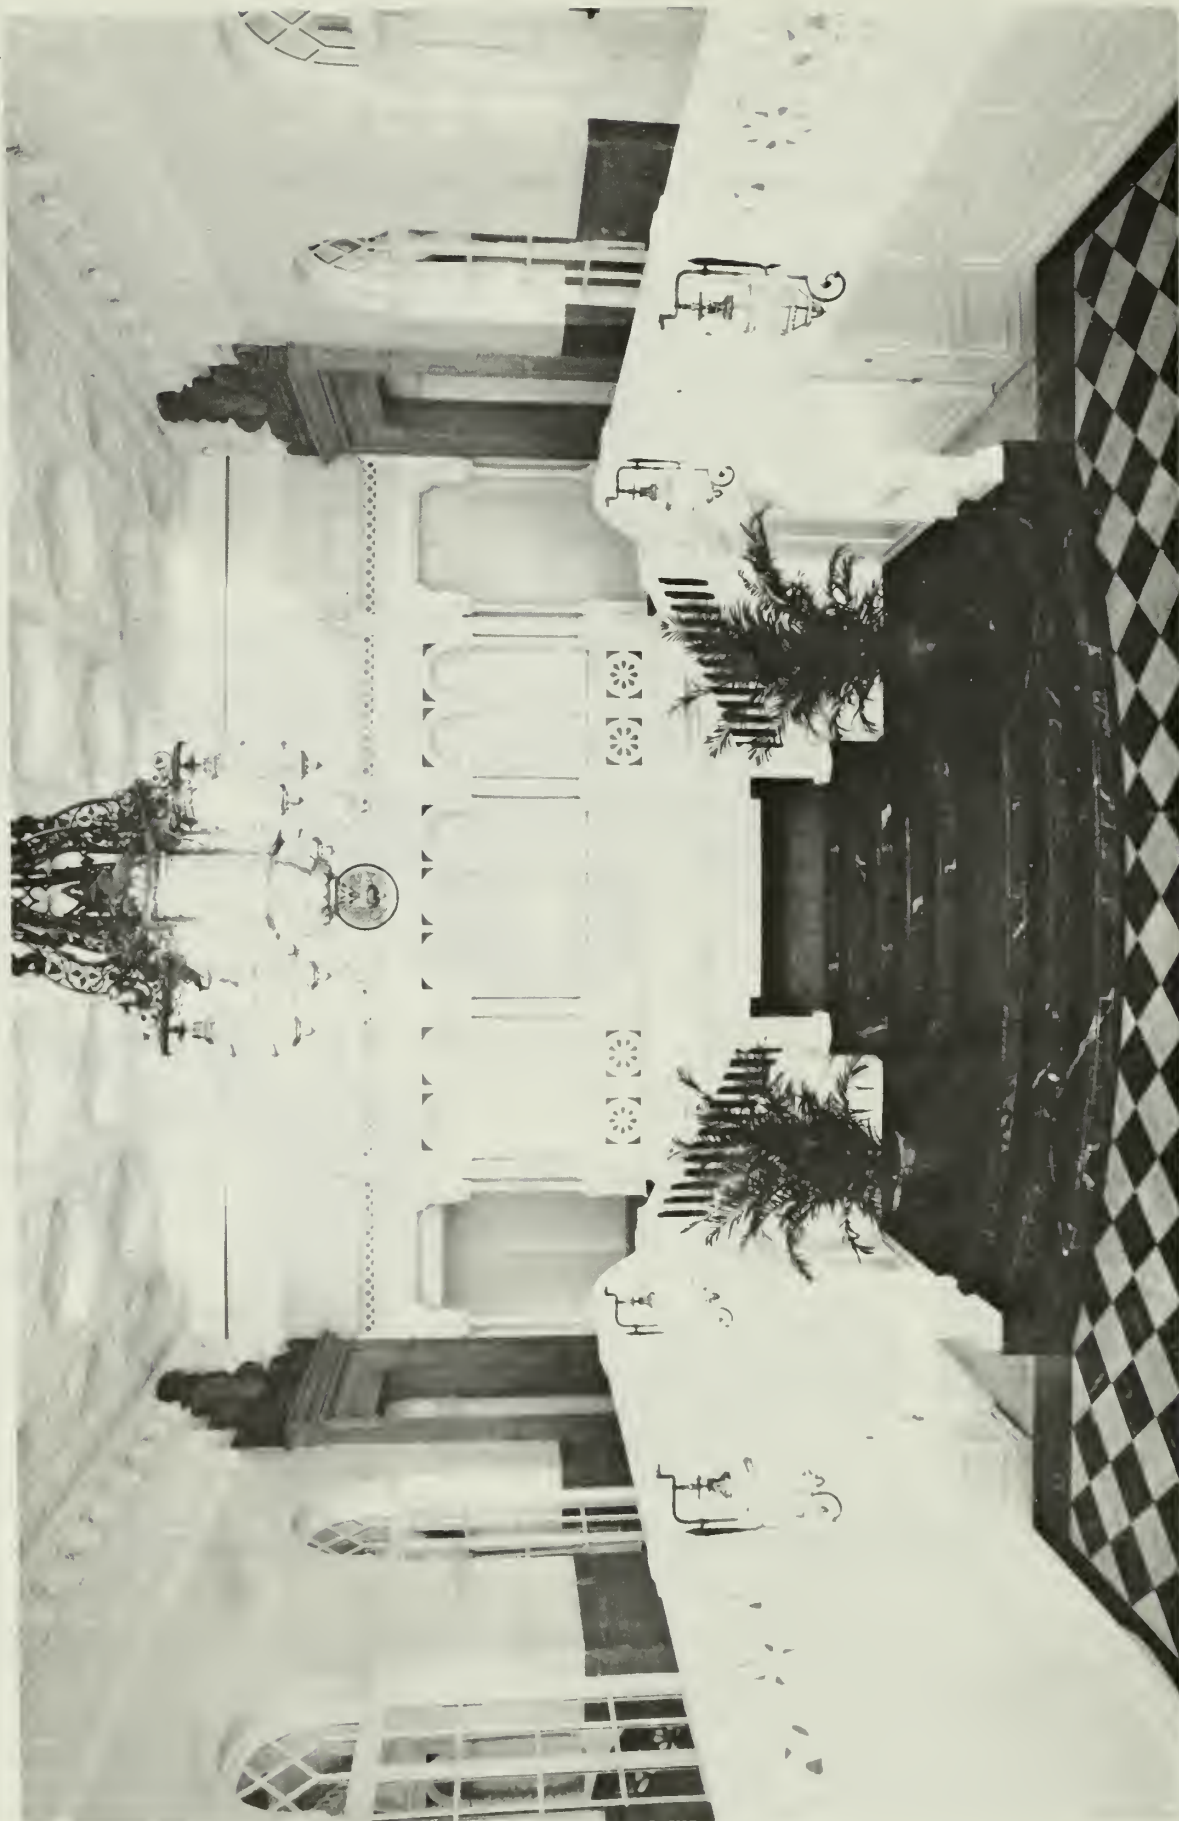
6. Lobby after rehabilitation. Partition behind screen closes off palm room and dining room from the lobby.

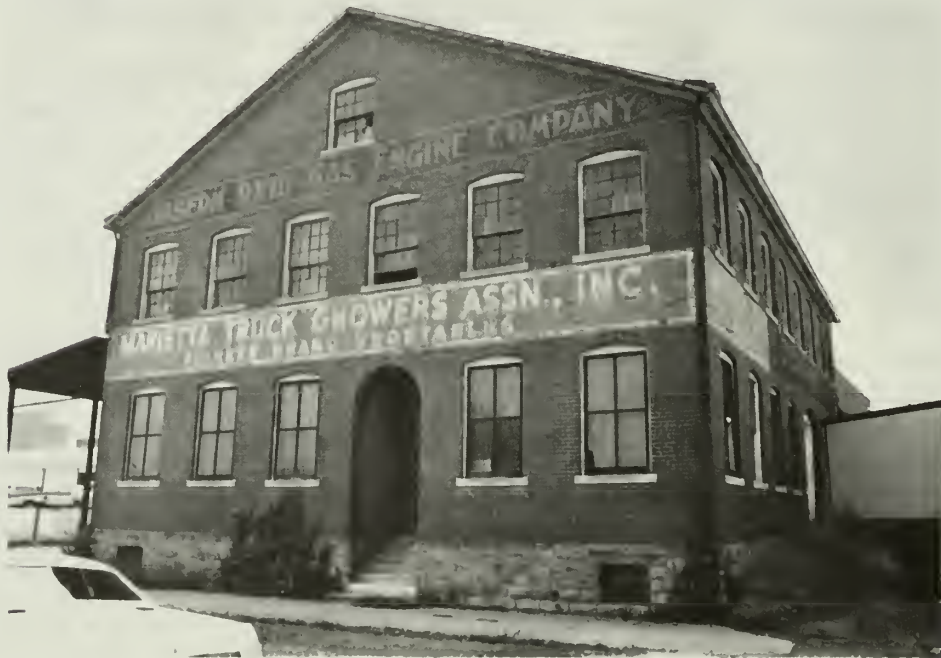
1. Front elevation of the 1880 manufacturing facility as it appeared prior to the rehabilitation.

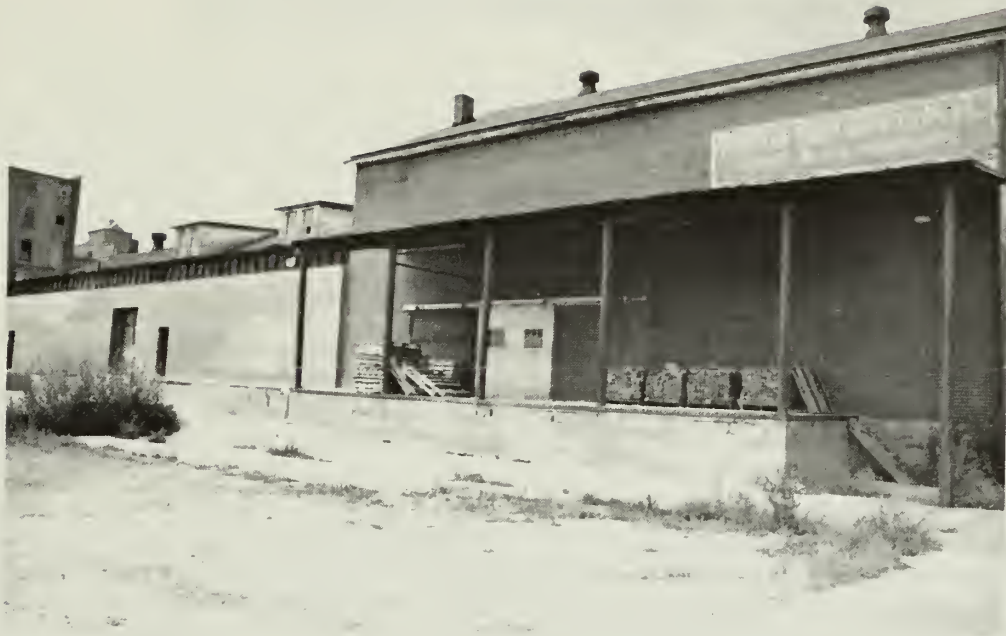
2. South side elevation of the building with roof-covered loading dock prior to rehabilitation.

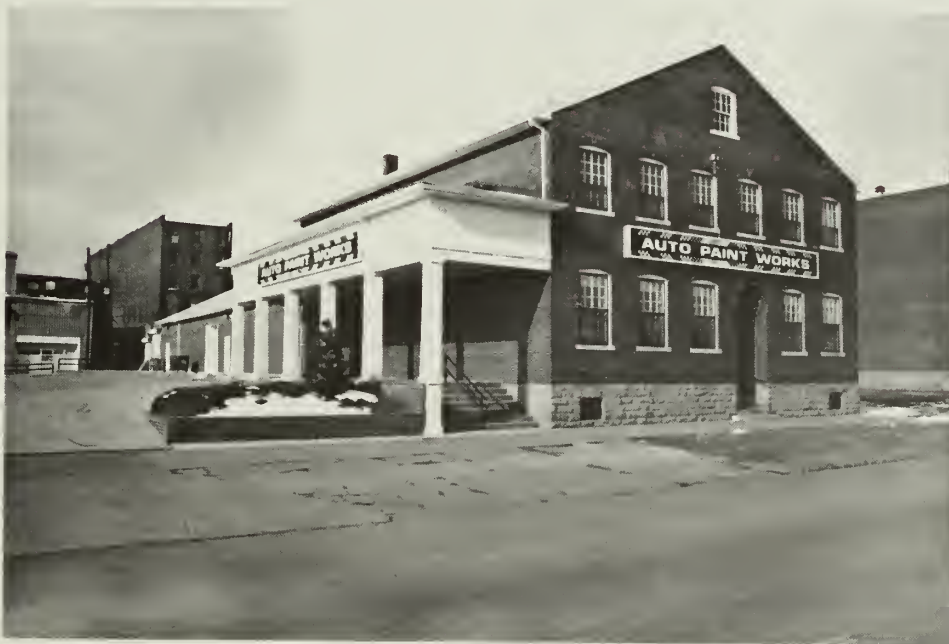
3. Photograph of building after rehabilitation with construction of portico.

The new porch, which retained and boxed in the surviving pipe columns from the old roof, is located in the same general location as that roof (see illus. 3). However, it differs from the old in design and scale. It has larger columns and is three feet taller, thereby dominating the south side and front of the building. The new portico fails to meet Standard 9, in that its size and scale are out of proportion to the historic building. The new portico also departs from the industrial character of the building. With its deep entablature and massive formal columns, the new portico creates more monumental, classical architecture than is consistent with the function and historic character of this modest industrial building. The new portico hints of the Greek Revival, an architectural phenomenon much earlier than the date when this building was constructed.

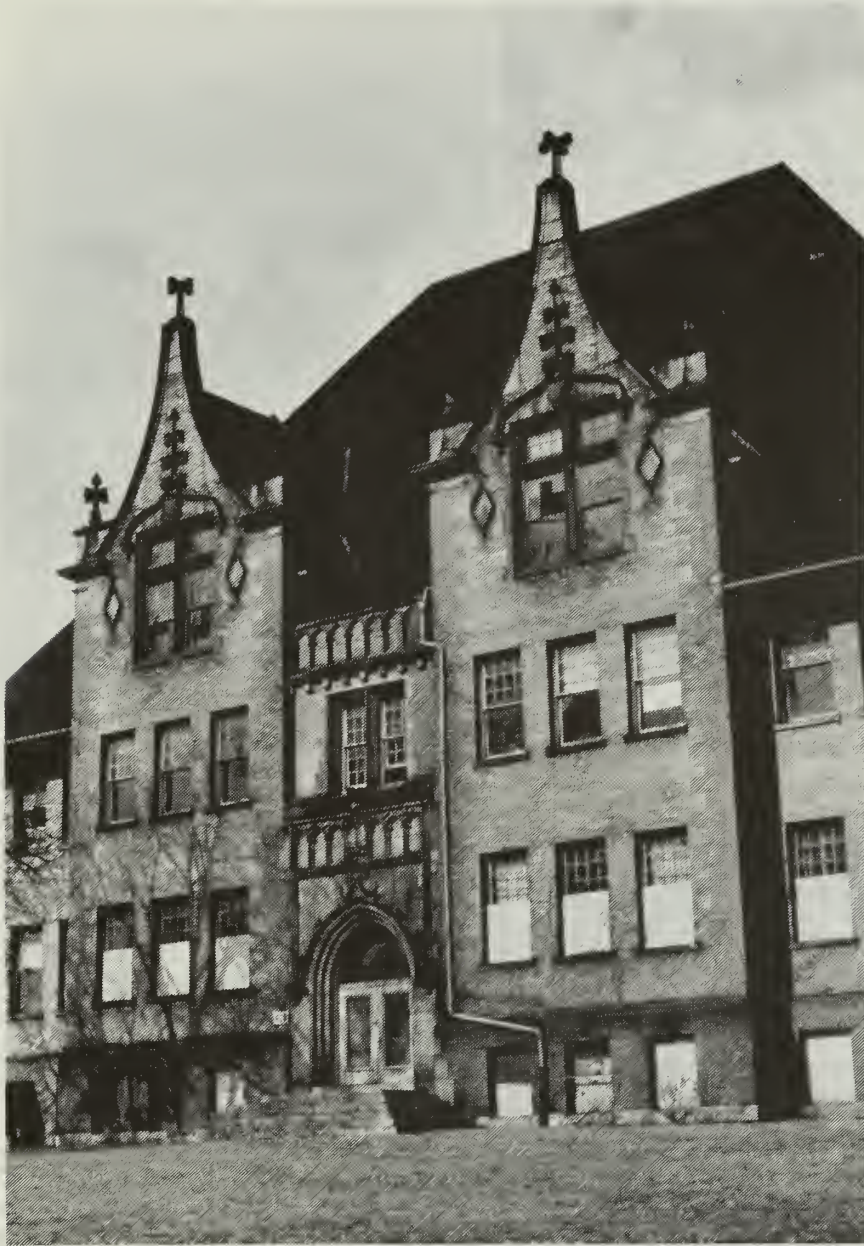
1. The former school building is characterized by its distinctive form--massive yet only three stories in height--its twin towers, unusual arch-shaped entrance and series of large-scale, twelve-over one windows that were designed to provide maximum daylight in the classrooms.

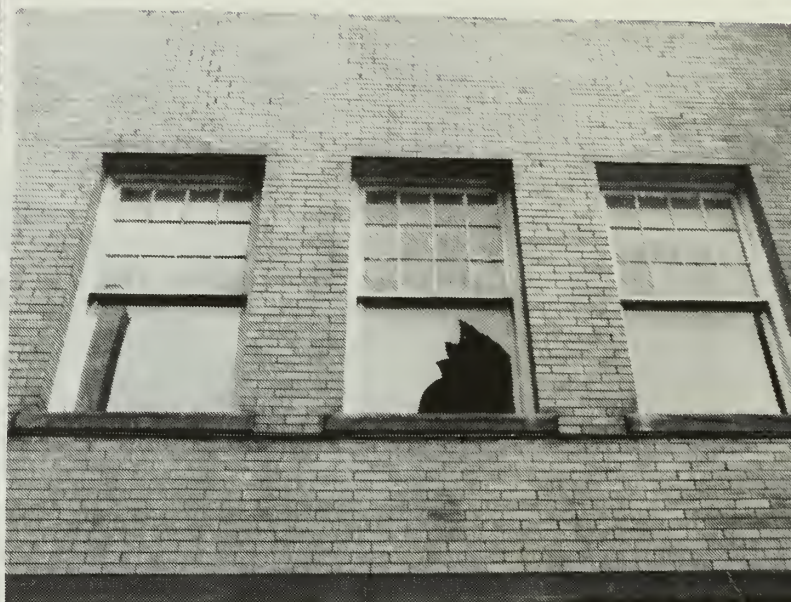
2. and 3. The windows and window openings as one would see them close to the building's walkway entrance establish the importance of their design and detail.

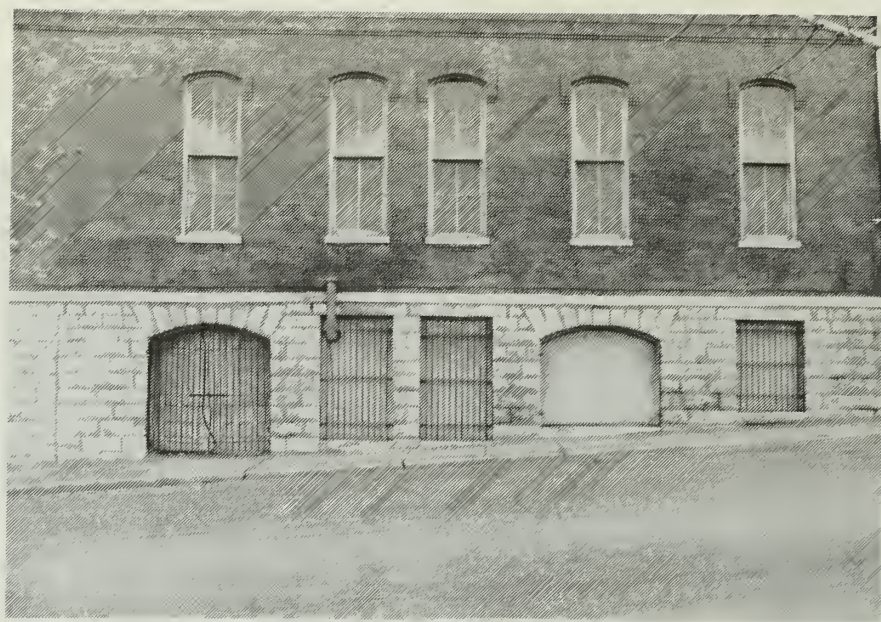
3. Before rehabilitation, the windows on another street elevation were four-over-four units that feature delicate, attenuated muntins. The historic window is a double-hung design; the shadow line that the meeting rail casts at the center of the two-part window is a distinctive quality.

Before and after photographs revealed several design deficiencies in the new window. Where one over one double-hung windows had existed historically on the building's primary facade, the replacement windows were a "fixed" design with both upper and lower sash on the same plane; the horizontal piece applied as a meeting rail is actually flat, and consequently unable to cast the familiar shadow line of the historic window. Finally, there was a dramatic difference in color, from a light cream color to dark brown (see illus. 1 and 2). On another key facade, where there had been historic four-over-four double-hung windows, fixed sash were installed, the light divisions were altered, wider muntins were used, and the color of the windows was changed (see illus. 3, 4 and 5).

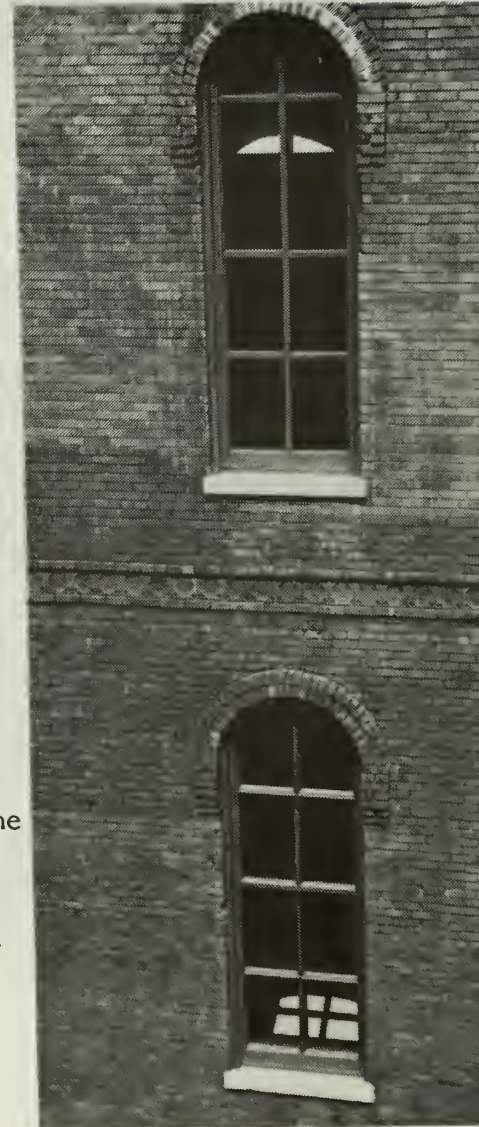
4 and 5. After rehabilitation, there is a striking change in the appearance of the entire facade due to the installation of inappropriate replacement windows. In addition to the obvious color disparity, the unit is noticeably on one plane rather than double-hung. The muntins are also much heavier and there is no meeting rail.

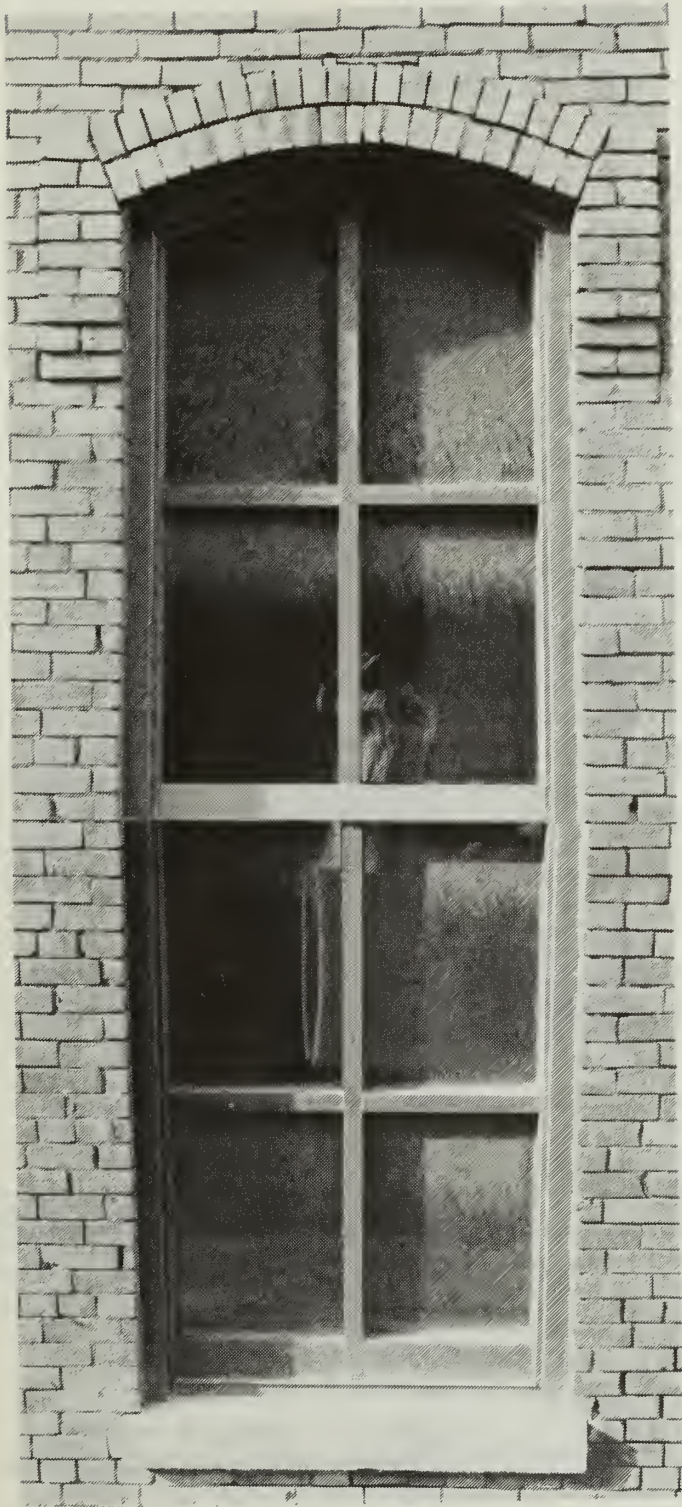
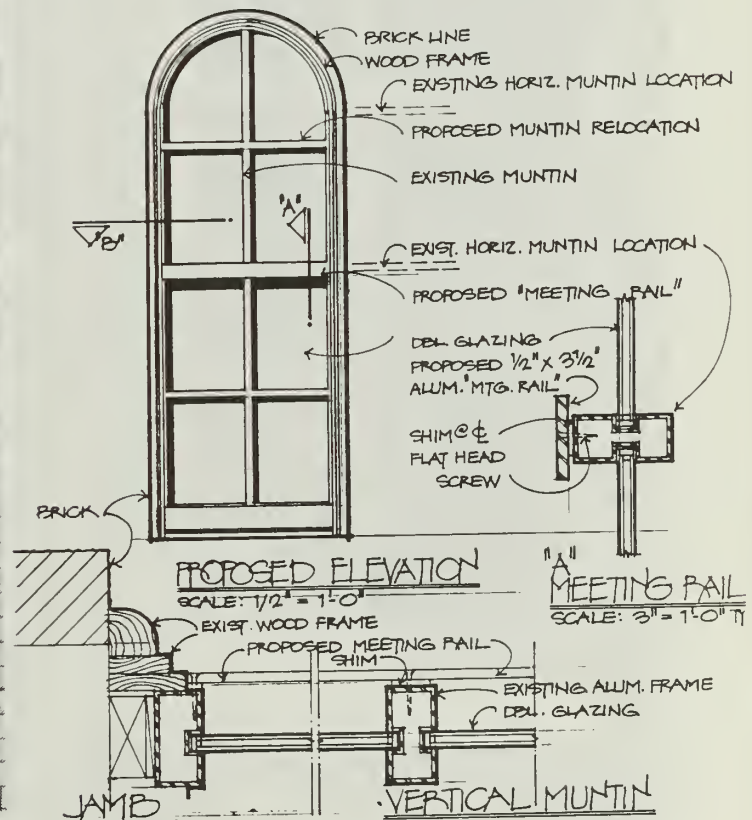
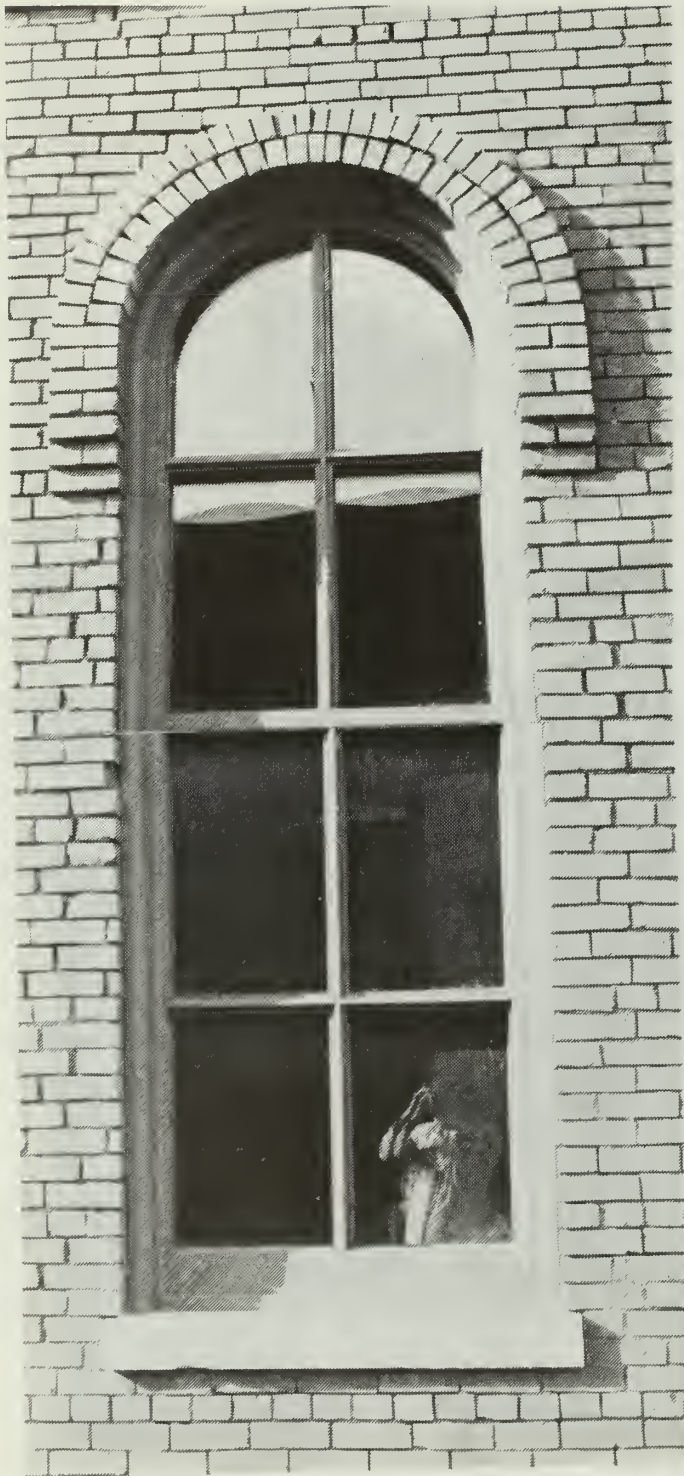
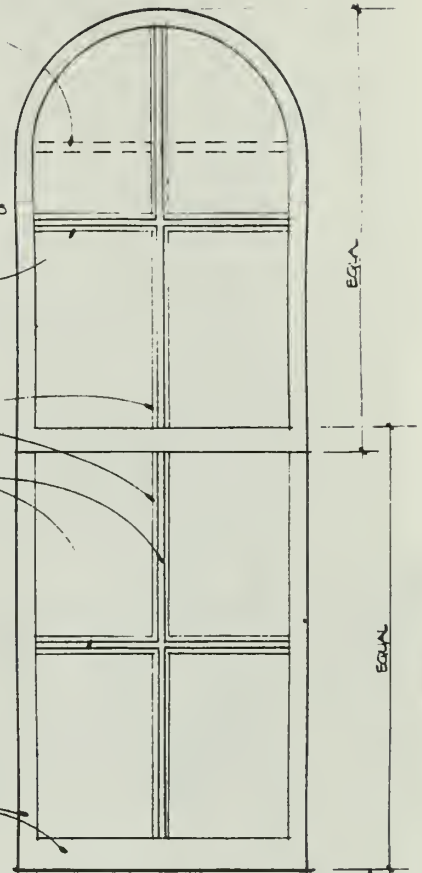
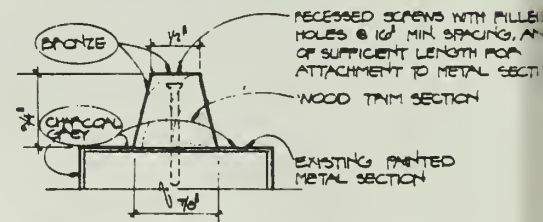
PROPOSED TREATMENT FOR "MEETING RAIL"

6. In an attempt to bring the inappropriate four-over-four replacement units (see 4 and 5.) into conformance with the Standards, two alternatives were proposed. In proposal A, the horizontal muntin at the top would be relocated so that all eight lights would be of equal size like the original. A 3 1/2" wide aluminum strip would be applied in an attempt to recapture some aspects of the meeting rail. Even after these adjustments, however, the upper and lower sash would read as a single, fixed unit; the muntins are also too wide and too flat.

REMOVE TOP HORIZONTAL
MUNTIN & GLASS

RESTRUCTURE WINDOW SO
TOP HORIZONTAL MUNTIN IS
MIDWAY BETWEEN TOP SASH
SECTION

APPLY WOOD TRIM SECTION
TO PAINTED MUNTINS

APPLY 3/4" THICK x FULL WIDTH
(OF EXISTING SECTION) WOOD
SECTIONS TO HORIZONTAL &
VERTICAL PERIMETER SECTIONS
& TO HORIZONTAL MEETING PAIR
COLOR TO BE BRONZE

FRAME ELEVATION

WOOD TRIM DETAIL

After NPS denial, the applicant sought to bring the replacement windows into conformance by a series of cosmetic changes, including relocating the horizontal muntin at the top of the four-over-four window, and applying wood trim to the aluminum muntins in an attempt to create a thinner appearance (see illus. 6 and 7). This proposal was also rejected by NPS on appeal. In a final letter to the owner, the Chief Appeals Officer explained:

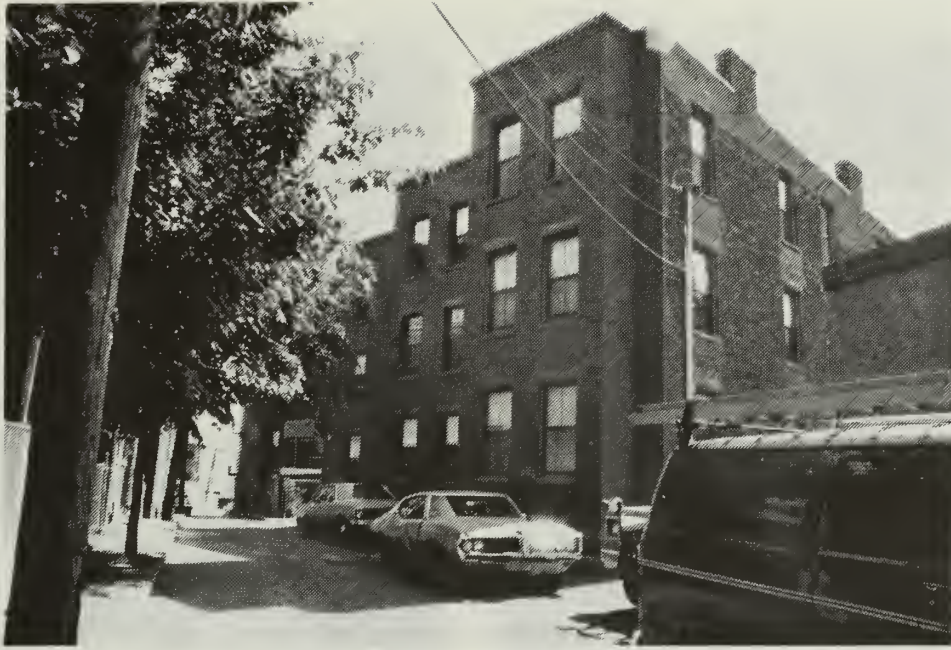
1. Pre-rehabilitation photograph of workers' rowhouses (front elevation).

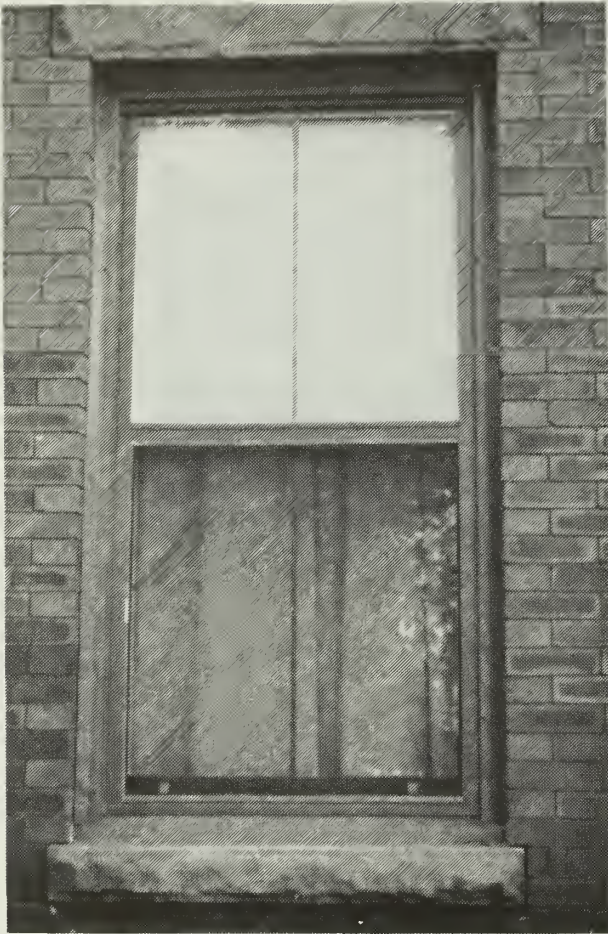
3. Post-rehabilitation photograph of aluminum replacement window. The vertical muntin was sandwiched within the insulating glass and the double-hung appearance changed since the screen panel was installed directly below the fixed upper sash.

In the course of the rehabilitation, all the historic wood window sash, which were deteriorated and not salvageable, were replaced. The replacement windows installed consisted of a single-hung aluminum window with fixed upper sash and a screen panel placed directly below the upper sash in the same plane, a meeting rail considerably wider than the original, muntins sandwiched between the glass, and a bronze colored finish (see illus. 3). These windows were determined not to meet Standard 6 in that they did not match the existing windows in design, color, profile, and muntin configuration.

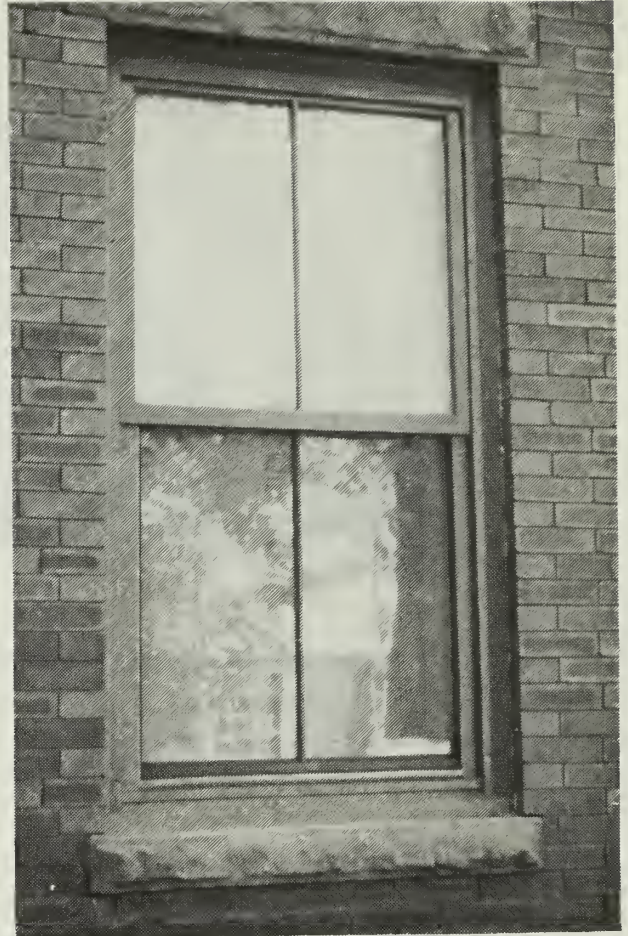
4. Aluminum replacement window with a wood mock-up of an applied unglazed sash frame and muntin placed over the upper aluminum sash. The applied frame and muntin look like temporary add-ons, rather than matching the historic sash.

milled of wood and applied over the existing flush metal sections of the new aluminum windows (see illus. 4). However, it was determined that this modification did not capture the historic appearance of the existing wood windows. Wood frames fabricated with central dividing muntins and applied to each window would not faithfully duplicate the configuration of the old windows and would read as a temporary treatment, rather than an integral component of the sash. In view of the proximity and visibility of these windows to the street, any superficial or cosmetic change to the existing replacement sash, regardless of material, would not be consistent with the historic character of this building.

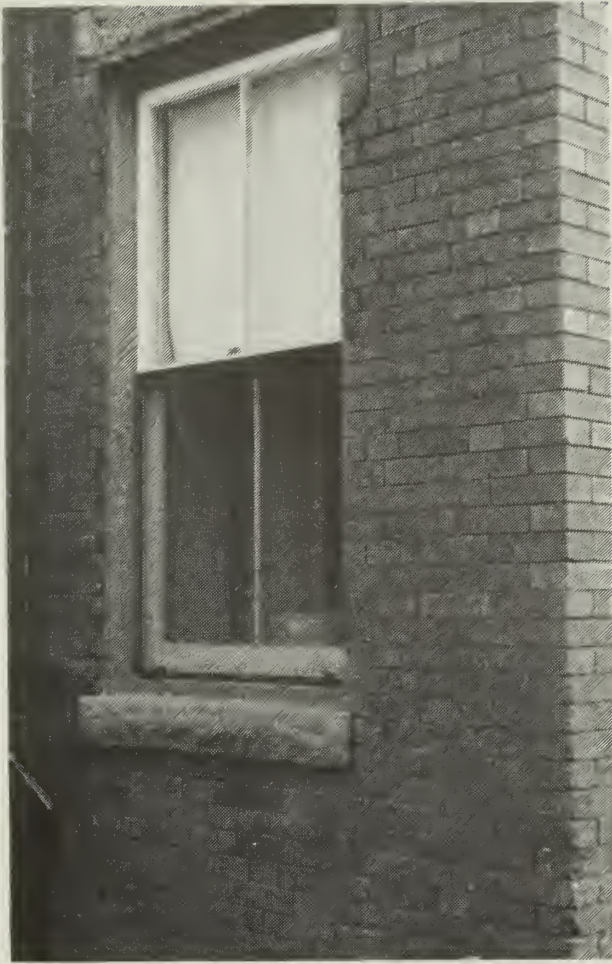
5. New wood replacement window as approved. If possible further refinement (although not required in this case) would have been to install the half screen on the inside rather than on the front of the upper and lower sash.

To bring this rehabilitation into conformance with the Standards, the owner decided to replace the new aluminum windows, which were clearly visible from the street, with new wood sash duplicating the originals in size, profile, muntin configuration, and composition (see illus. 5 and 6). With the new wooden sash in place, the project was subsequently certified.

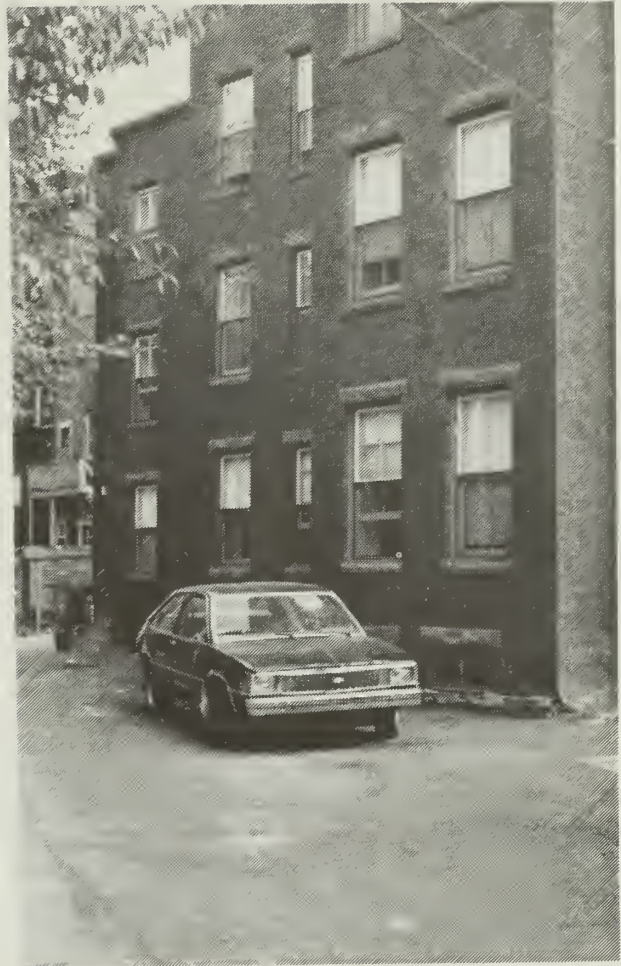
6. Post-rehabilitation photograph of historic rowhouses with matching wood windows.
